June 27, 2018

Version 2

Safety Recall: 2004–08 TSX Power Steering Feed Hose LeakSupersedes 10-010, dated May 11, 2010, to revise the information highlighted in **yellow****REVISION SUMMARY****Under Warranty Claim Information, the failed part number was changed****AFFECTED VEHICLES**

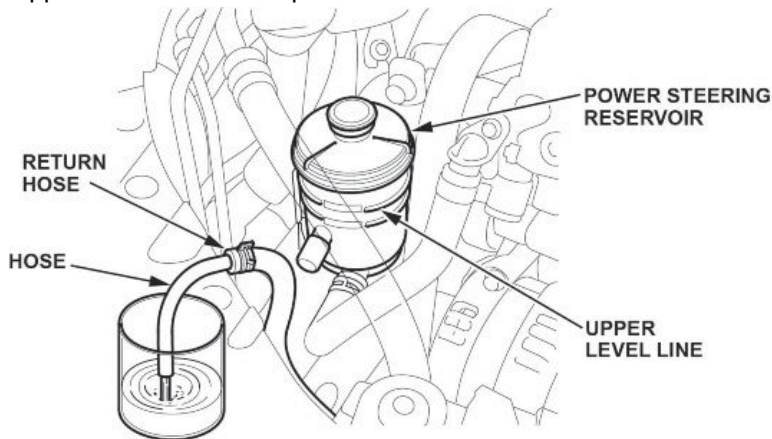
1. Raise the power steering reservoir, then disconnect the return hose, and drain the reservoir. Plug the return hose nipple with a suitable cap.

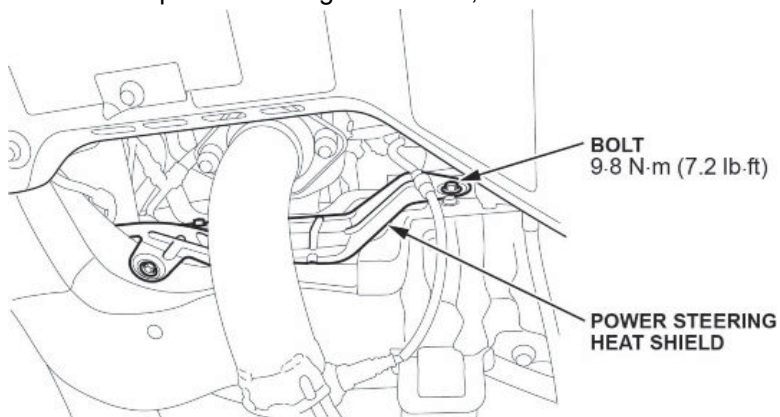
4. Remove the cap from the return hose nipple on the reservoir, then reinstall the return hose on the reservoir.
5. Raise the vehicle on a lift, and make sure it is securely supported.
6. Remove the power steering heat shield, then lower the vehicle to the ground.

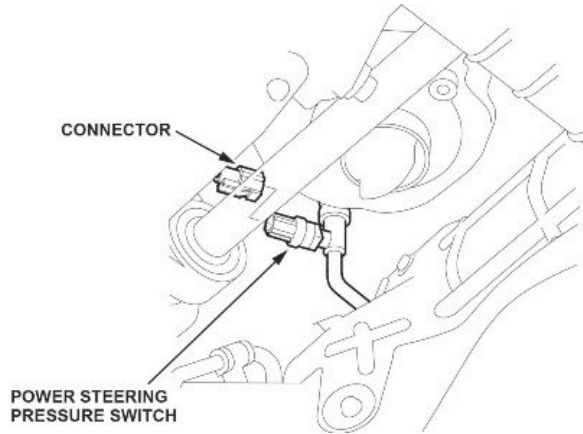
7. Disconnect the power steering pressure switch connector.

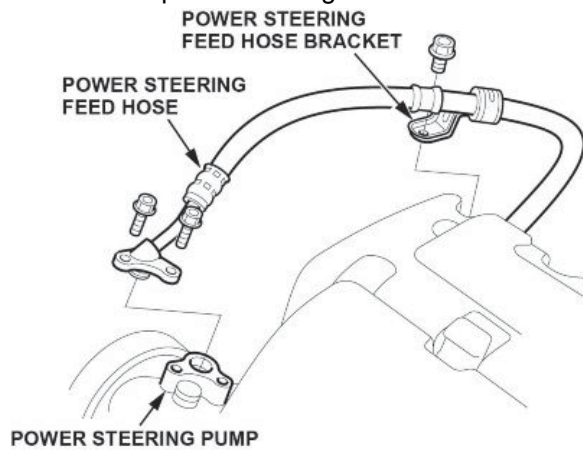
8. Remove the power steering feed hose bracket from the cylinder head.

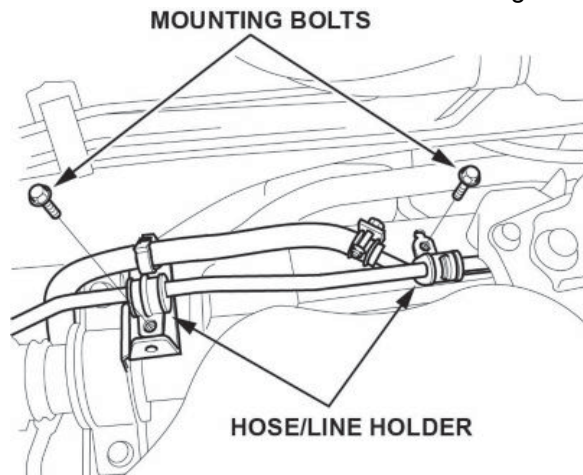
10. Remove the feed hose/line holder mounting bolts and the feed hose/line holders.

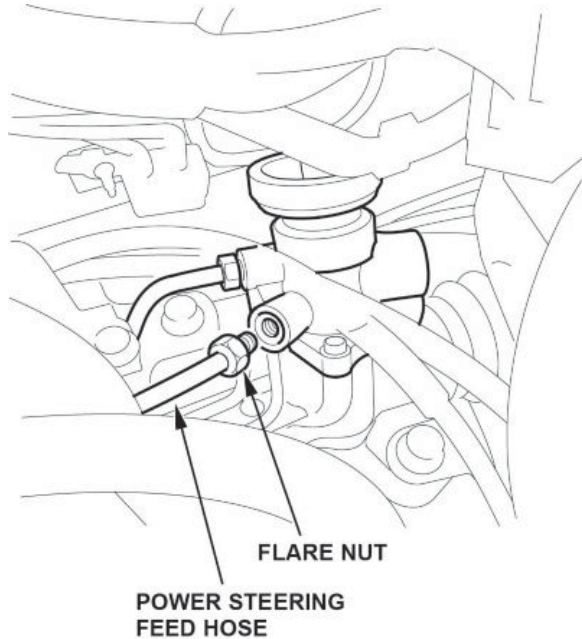
11. Disconnect the power steering feed hose from the gearbox by loosening its flare nut.

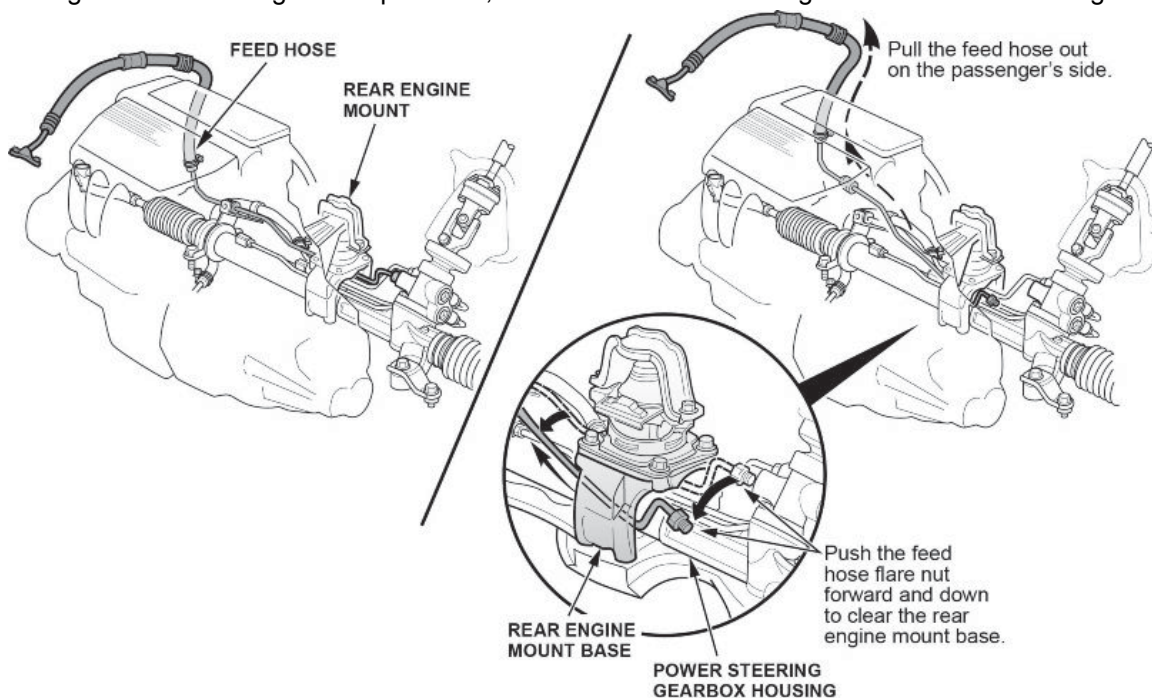
12. Within the rear engine mount base, position the feed hose toward the front of the vehicle. Pull the feed hose toward the right side of the engine compartment, then route the hose through and out of the rear engine mount base.

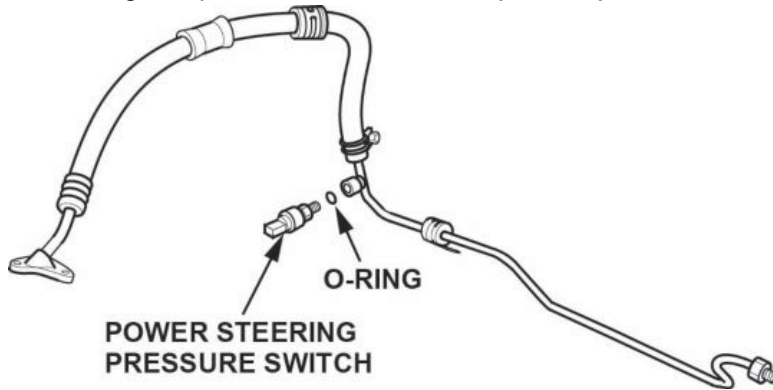
13. Remove the power steering pressure switch from the original feed hose, then install it on the new feed hose with a new O-ring. Torque the switch to **12 N·m (8.8 lb-ft)**.
